SR-150 RESTORE

BY WDØGOF

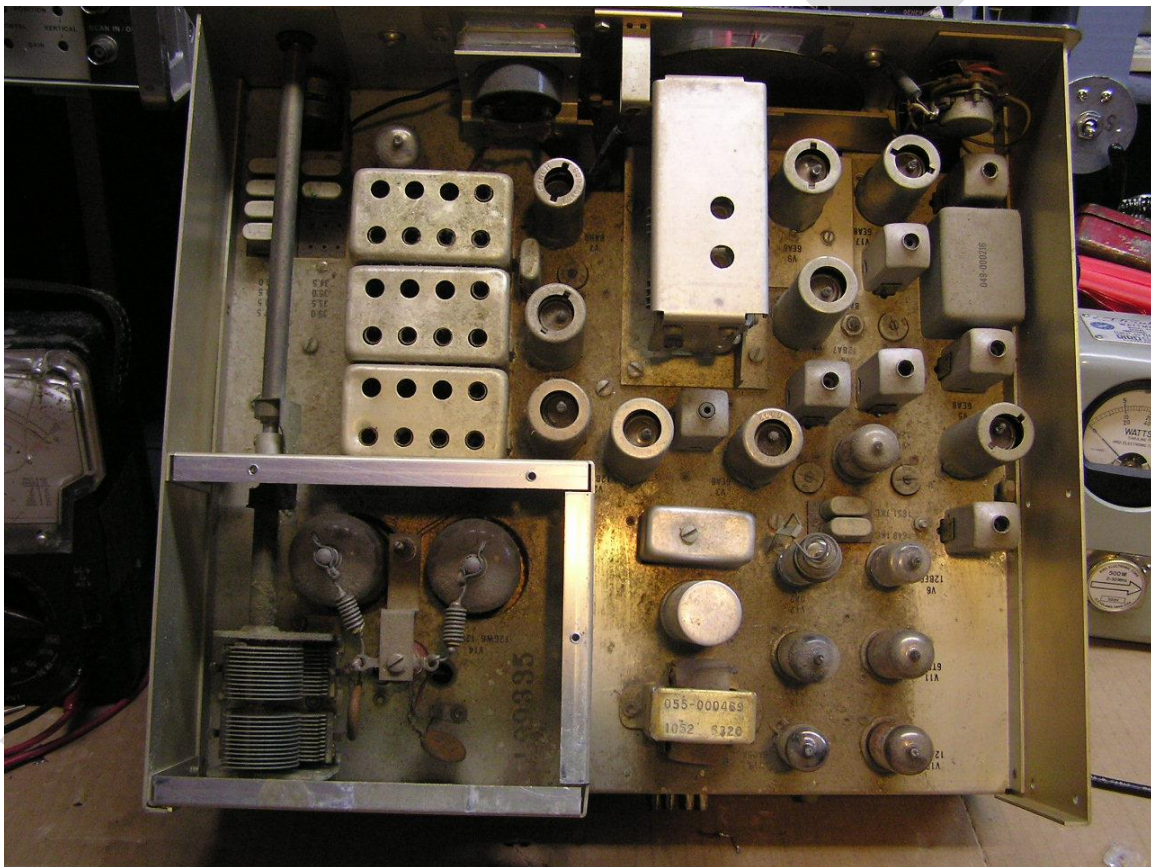
This was an easy one it only took 4 years(*stay tuned for the rest of the story*). I purchased this radio on e-Bay for \$121, from a ham in Averill Park, NY in June of 09. The power supply was not included, I have several spares. I started the restoration in Aug 09. The radio was complete with a good case and a very good front panel. It had been stored for a very long time and was thick with dust and dirt inside. It is a run 7 radio which means it had all the latest improvements. It still has all original components and appears to have some minor tinkering inside. A visual inspection revealed a broken tube socket and a vaporized contact on K1. The K1 contacts involved are the contacts to an external relay used to control and external power amp. The wires from the three relay contacts have all been over heated and will need to be replaced.

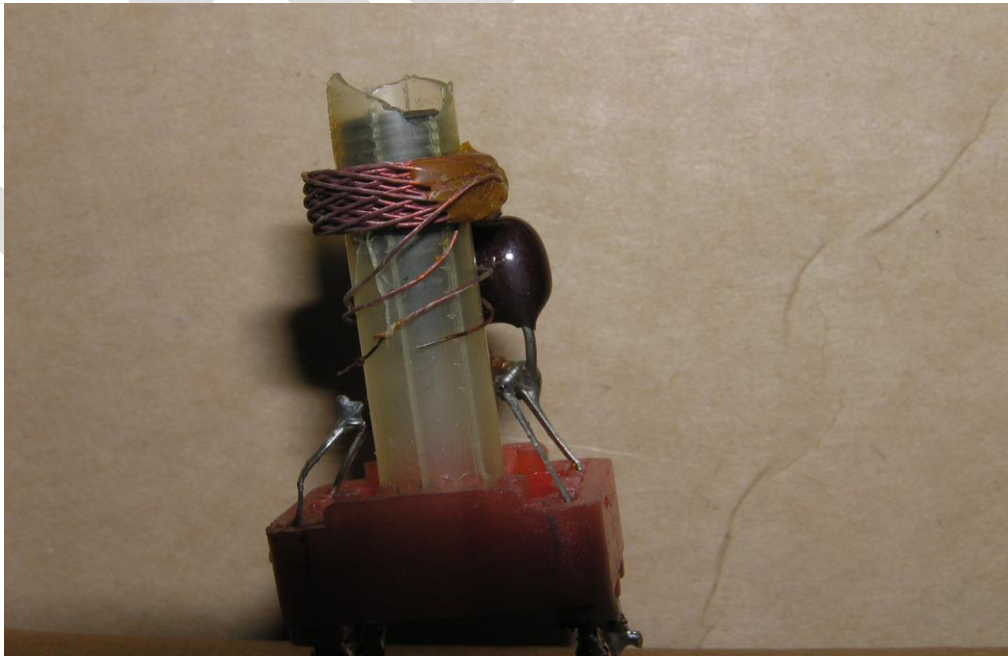
At this point I could not stand it, I had to see if it worked even with the bad tube socket. The relay problem doesn't impact normal operation of the rig. Upon power up there was no TX or RX. I quickly located the problem, no carrier osc, no plate voltage on V10. T4 open, I discovered the slug was frozen. At that point I had a hunch about what had happened. A prior owner tried to adjust the slug and had spun the form in the base. Inspection confirmed this as well as a broken form.

I had a T4 in a parts rig, replaced it and the rig actually worked. The receiver actually met factory specs but was not up to standard performance. The transmitter worked, but max output with a new matched pair of finals was 40 watts. So now its power down and start replacing wires, resistors, capacitors, relays and tube sockets. I got very busy in the shop so it went on the shelf.....

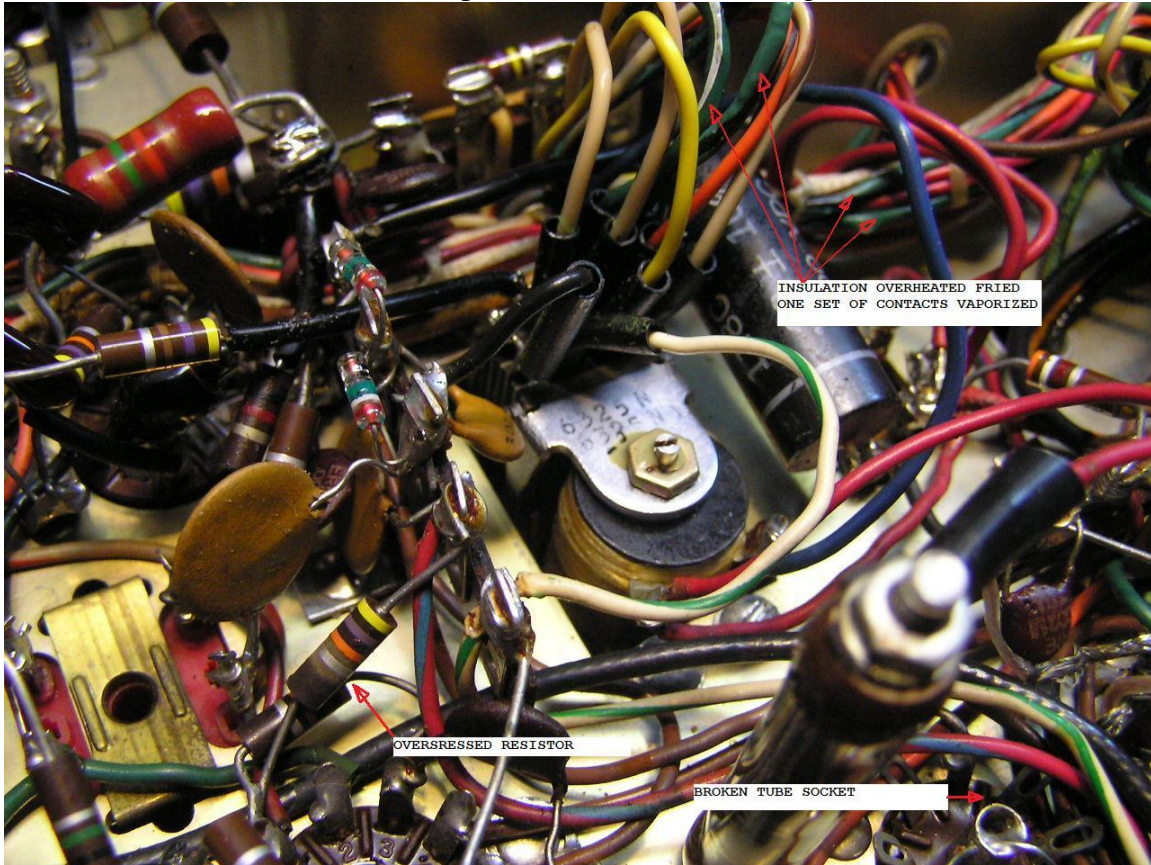
Visual inspection found the following:

..... Well it is now July 2013, in the process of closing down the shop. I finally have time to work on my own rigs. I pulled this baby off the shelf and put it on the bench. I replaced the burned resistor, the tube socket, electrolytics and rewired K1. I then tested all the tubes and replaced a few. None were bad just on the low side. A "by the book" track and alignment brought it totally in spec. One problem left. The VFO didn't stabilize until it had been on for 90+ minutes. Even then it was just barely in spec. I did the zener mod to the CAL/RIT ckt, and replaced the dog bone caps in the VFO. Now at about 20 minutes it is much more stable than spec.
