# SR-2000 PA BAND SWITCH REPLACEMENT BY WD0GOF

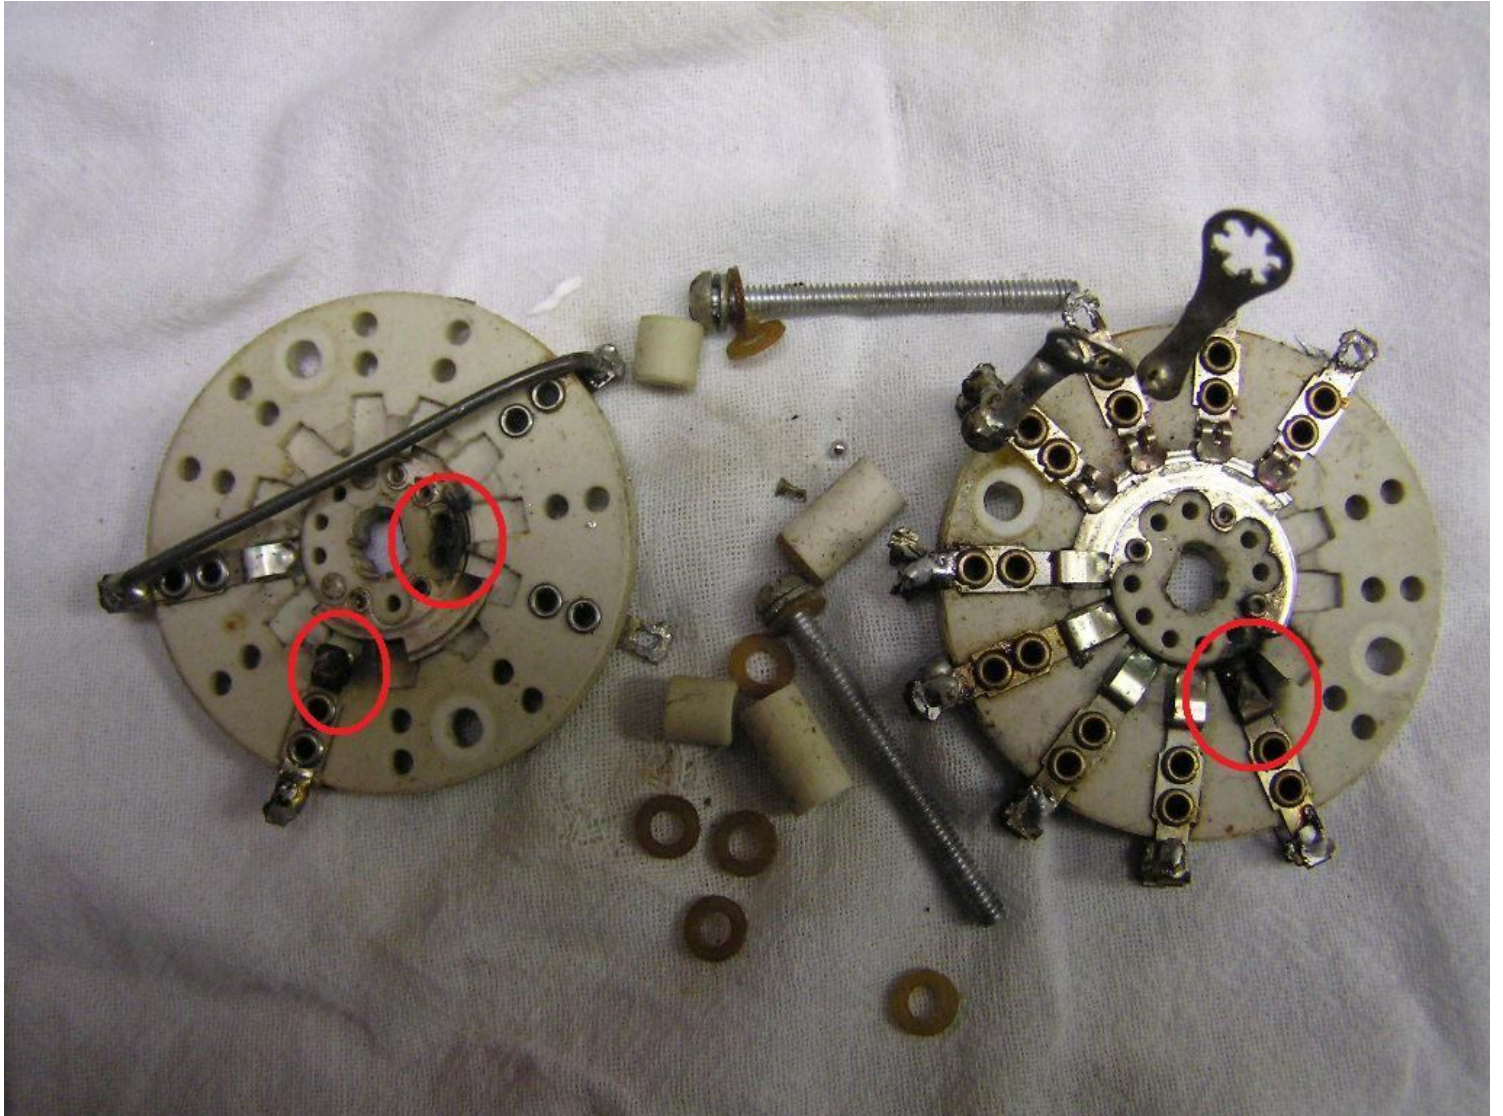
Now it is a little easier to see the damage.
